Analysis of the failed pinion from the drive of a cement mill

BORUT KOSEC^{1,*}, GORAZD KOSEC², IGOR BUDAK³, ALEŠ NAGODE¹, ACO ANTIĆ³

Abstract: The pinion from the drive of the cement mill was failure. The teeth ruptured and peeling occurred on the sides of some teeth. The failure was only located on one side of the pinion. This type of failure is common with surface-hardened gears. We have found that the failure of the pinion is a direct consequence of the incorrect geometry of the surface hardened layer. The lifespan of the pinion could have been extended if the whole surface of the faces and roots of the teeth had been hardened and if the hardening had been deeper.

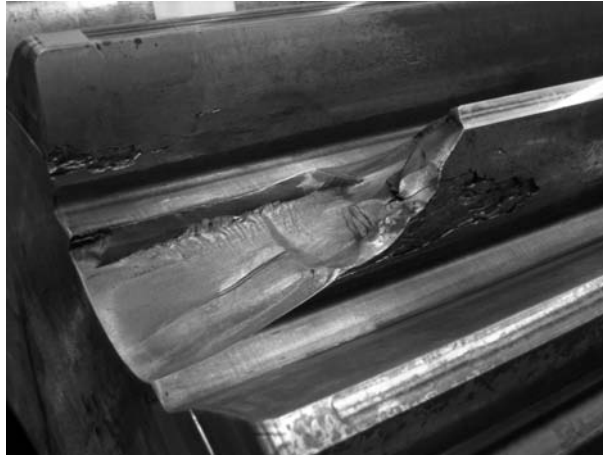
The failure of the pinion of the cement mill drive (No. 354881, teeth 28, module 36, diameter 1640 mm, width 1800 mm) occurred in the form of fatigue cracks and the peeling of steel on the faces of several teeth. The failure was only located on one side of the pinion (Figure 1). The teeth breakage began with ruptures, which typically started at the roots of the teeth faces and spread outwards. The breakage resulted in transverse ruptures along the height of the teeth.

The other failure that occurred was the peeling of the steel on the faces of the teeth. Such failure is caused by excessive Hertzian pressure applied to the faces, or is a consequence of the lack of compressive strength of the steel at a critical depth of the teeth surface. In this way, the unbroken teeth are also failed, but the extent of this type of damage was significantly smaller in our case.

Figure 1. Failure of the pinion: part of the broken off tooth, and the peeling of steel on the faces of the teeth

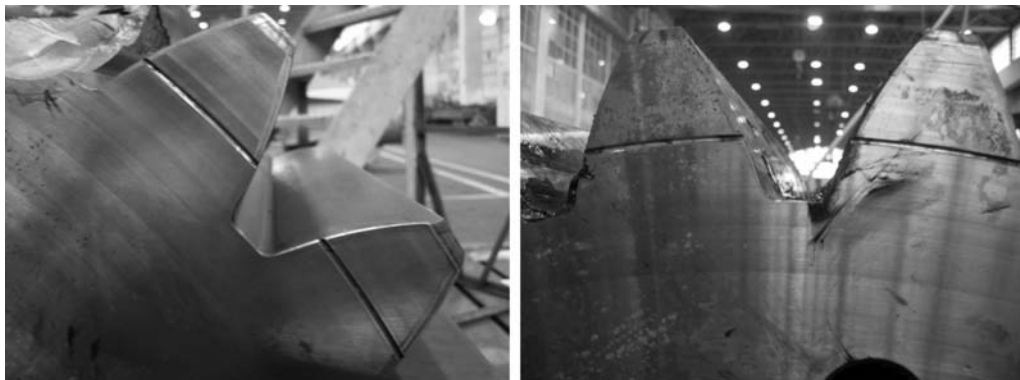
Figure 2. A broken tooth and two unbroken teeth with a fatigue crack (left). Two failed teeth: the lines indicating the heated surface (right).

at the undamaged side of the gear.^[7, 8] The hardened areas were along the faces and at the roots (Figure 2), and were interrupted at the top of the teeth.

which is approximately 1 mm, which generally starts at the top of the tooth and ends approximately 10 mm above its root. The macroscopic profile of the teeth's surface hardened layer is not satisfactory. It has two disadvantages: it only covers a part of the teeth faces, and it is very thin. The entire surface of the faces and roots should have been hardened; it is not necessary to harden the surface at the top of the teeth. The macroscopic characteristics of the surface areas of the ruptures show that the ruptures are a consequence of the fatigue of the steel.^[10, 11]

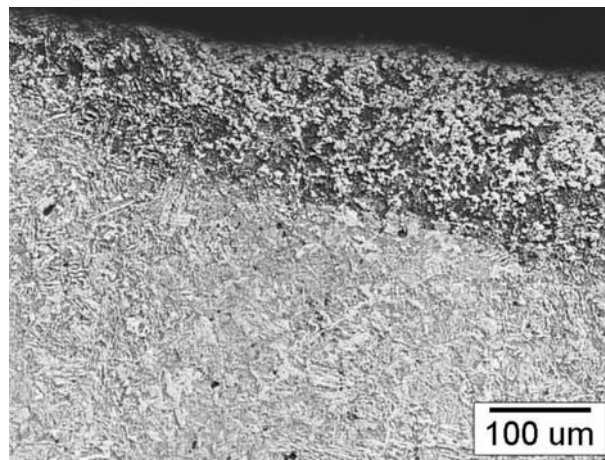
The microstructure of the pinion steel reveals that the pinion was previously strengthened and its surface was hardened (Figure 3).

Figure 3. The area where the hardened surface of the tooth ends (OM)

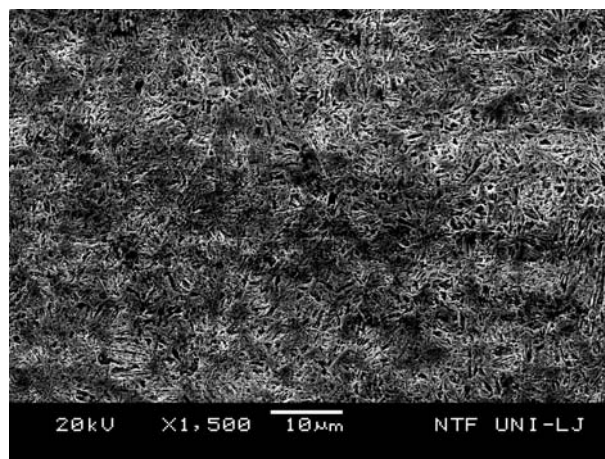
The microstructure of the steel at the core of the tooth consists of tempered bainite and ferrite. On the faces of the teeth, where the steel surface is hardened, the microstructure consists of martensite (Figure 4). The martensitic microstructure of the hardened surface transforms through a binary micro-

Figure 4. Microstructure of the steel at the hardened surface: martensite (SEM)

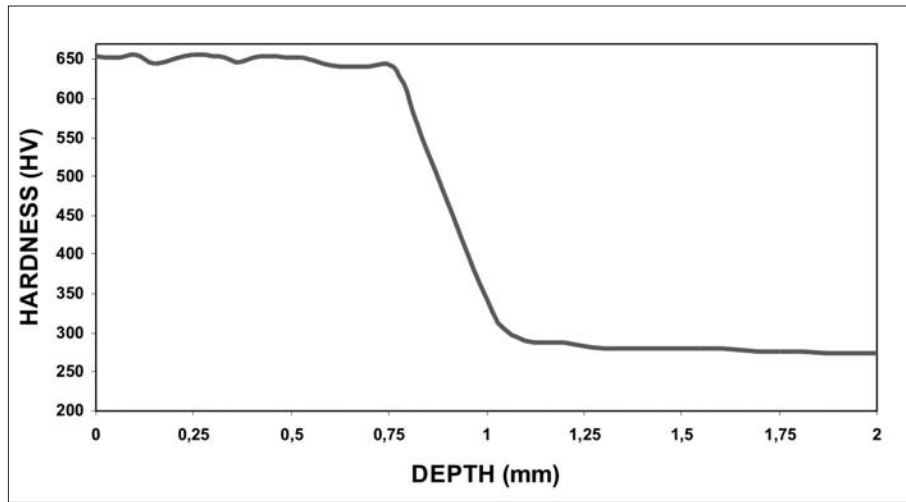
The constant hardness (approximately 650 HV) is characteristic of the hardened surface of the pinion, and gradually decreases over a transition zone to the hardness at the tooth core (approximately 275 HV) (Figure 5).

Figure 5. Microhardness in the hardened surface and transition to the core

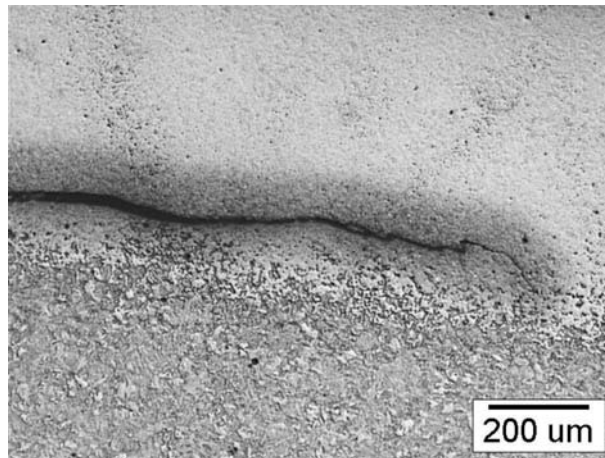
Figure 6. Crack at the point of transition from the hardened surface to the core (OM)

The peeling of the steel on the teeth faces is a consequence of excessive Hertzian pressures, which exceed the compressive strength of the steel. The critical area where the cracks and peeling first occurred is at the point of transition between the hardened surface

(martensite) and the core of the tooth, where the mechanical properties of steel (strength) begin to decrease rapidly (Figure 6).
