Hydrogeological risk factors of dam and reservoir construction - a case example “Bogovina”

PETAR DOKMANOVIC, IGOR JEMCOV, SASA MILANOVIC, BOJAN HAJDIN

Faculty of Mining and Geology-Department of Hydrogeology, Djusina 7 str.
Belgrade, Serbia and Montenegro

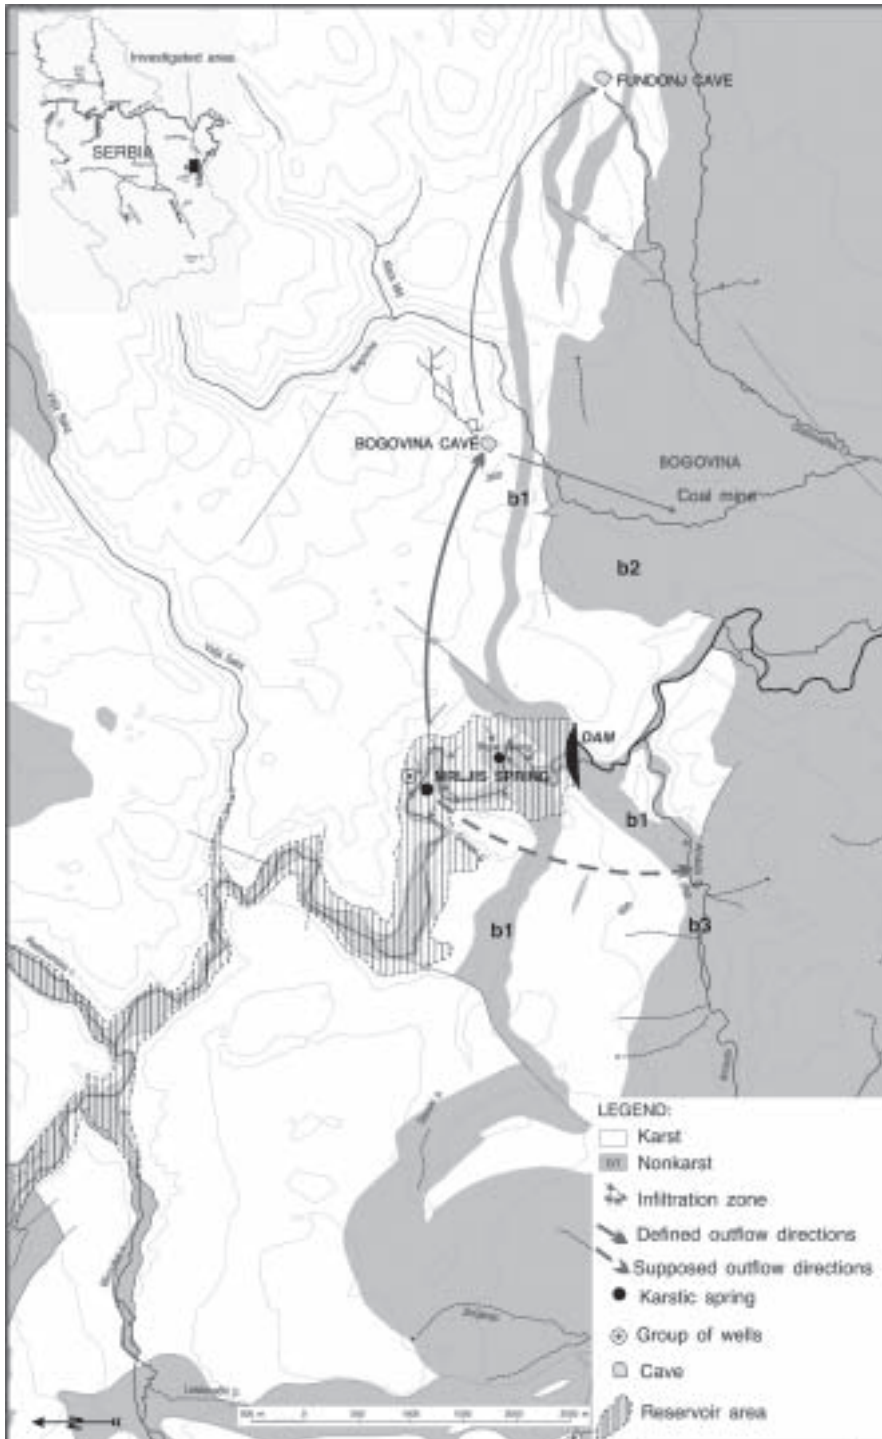
Figure 1. Simplified hydrogeological map

The investigated area belongs to the Karpat-balkanoid’s arc of the Eastern Serbia, which is characterized by significant presence of Mesozoic limestone-karst, with complex relations with non-carbonate rocks (Figure 1).

The limestone rock massif is characterized by well developed morphological karstic forms. The largest one is Bogovina Cave (Figure 1), in the contact zone between limestone (karst aquifer) and orbitoline sandstone (b1) and Oligocene sediments of Bogovina basin (b2), as the hydrogeological barriers. Barrier role of Oligocene sediments was deteriorated artificially by coal mining, which causes induced subsidence and fractures. A major part of karst ground water discharge through the Mrljis spring and, during high water periods, through the temporary springs: Bogovina cave and Fundonj cave (Fig. 1).

During geological mapping, many important karstic zones have been identified with a particular emphasis on the left bank of the future reservoir area, as a potential infiltration zone of stored waters (Figure 1). Particular elevation points were determined as follows: Bogovina caves (266 m a.s.l.) and Fundonj cave (263 m a.s.l.).

The connection between different underground water levels in the Bogovina cave and Bigar spring zone (Figure 1) was confirmed during the pumping tests. These tests were done at several wells, located around the Mrljis spring area.

Exploration drilling and WPT results in sandstone, in dam site area (Figure 1), confirmed their hydrogeological role of partially permeable barrier. Previously tracer tests indicated this phenomenon. Highly developed karstic channel system, various hypsometric positions and azimuths of channels were determined during speleological explorations.

- 1) Underground flow toward Fundonj spring
- 2) Underground flow toward abandoned mine and
- 3) Surface drainage (by discharging from Bogovina cave) towards the riverbed of Bogovina River. In all three cases the drainage occur downstream (outside the river catchment) of foreseen reservoir area. (Figure 1)
